**DEPARTMENT OF TRANSPORTATION**

Contract #: 04-0120F4Cty: SF/ALA Rte: 80 PM: 13.2/13.9File #: 69.28**WELDING INSPECTION REPORT****Resident Engineer:** Pursell, Gary**Address:** 333 Burma Road**City:** Oakland, CA 94607**Report No:** WIR-016504**Date Inspected:** 21-Aug-2010**Project Name:** SAS Superstructure**OSM Arrival Time:** 700**Prime Contractor:** American Bridge/Fluor Enterprises, a JV**OSM Departure Time:** 1900**Contractor:** Zhenhua Port Machinery Company, Ltd (ZPMC), Changxing Island **Location:** Shanghai, China**CWI Name:** Mr. Xu Le Feng**CWI Present:** Yes No**Inspected CWI report:** Yes No N/A**Rod Oven in Use:** Yes No N/A**Electrode to specification:** Yes No N/A**Weld Procedures Followed:** Yes No N/A**Qualified Welders:** Yes No N/A**Verified Joint Fit-up:** Yes No N/A**Approved Drawings:** Yes No N/A**Approved WPS:** Yes No N/A**Delayed / Cancelled:** Yes No N/A**Bridge No:** 34-0006**Component:** Tower and Orthotropic Box Girder (OBG)**Summary of Items Observed:**

## WELDING INSPECTION REPORT

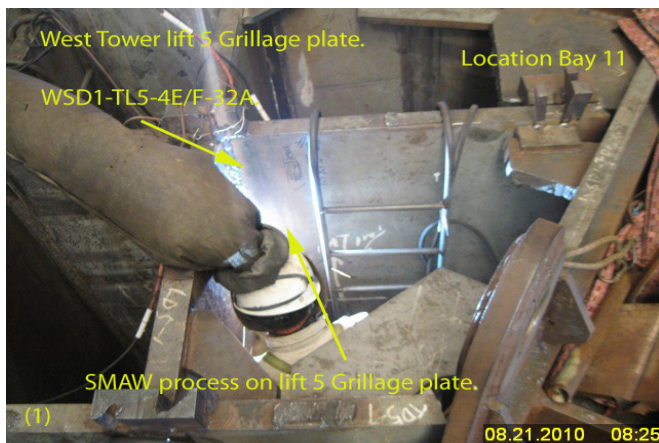
This QA Inspector observed ZPMC qualified welding personnel identified as 067611, Perform Shielded Metal Arc Welding (SMAW) on West Tower lift 5 Grillage plate. Joint identified as WSD1-TL5-4E-F-32A. ZPMC QC Identified as Zhao Mao Mao. The welding parameters as measured using QC's calibrated instrument appeared to be in general compliance with WPS-B-T-3213-Tc-P5b. For more information see below attached picture number 1.

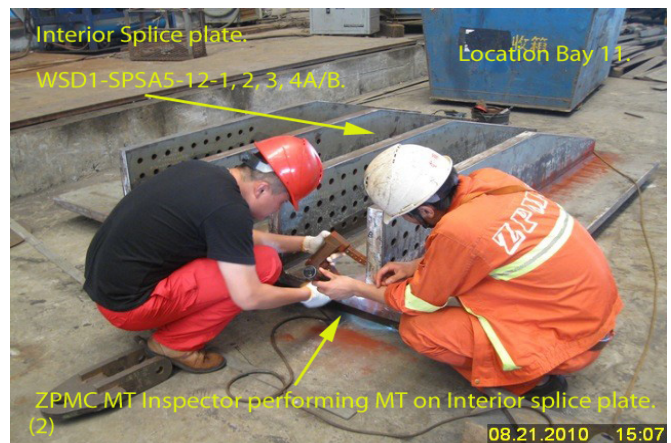
This QA Inspector observed ZPMC Magnetic particle Testing Inspector, performing MT on Interior Splice plate. Joint identified as WSD1-SPSA5-12-1A/B, 2A/B, 3A/B, and 4A/B. For more information see below attached picture number 2.

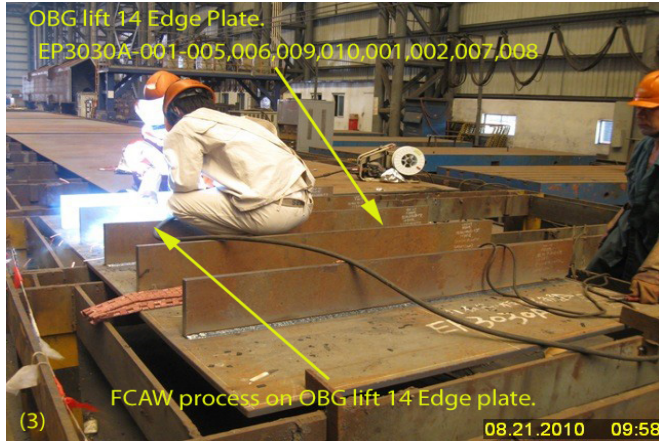
This QA Inspector observed ZPMC qualified welding personnel identified as 040759, 046706, Perform Flux core Arc Welding (FCAW) on OBG lift 14 Edge plate, Joint identified as EP3030A-001-005, 006, 009, 010, 001, 002, 007, 008. ZPMC QC Identified as Ma Qianli Ma. The welding parameters as measured using QC's calibrated instrument appeared to be in general compliance with WPS-B-T-2132. For more information see below attached picture number 3.
